MIPS Campaign A1

September 10, 2003

MIPS 70 Micron Array Readout (Channel 2) Anomaly ISA Z81711

September 9, 2003

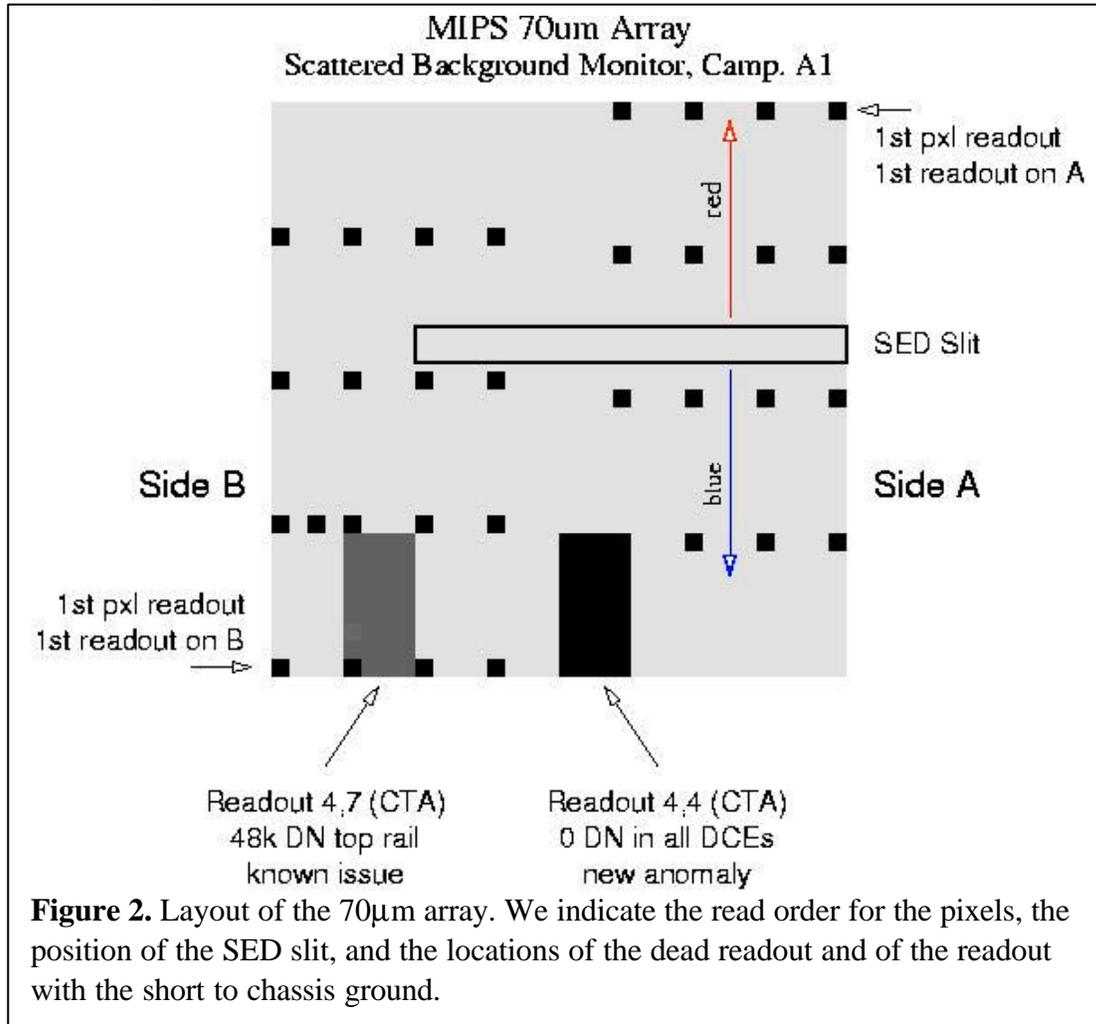
Figure 2. Layout of the 70 μ m array. We indicate the read order for the pixels, the position of the SED slit, and the locations of the dead readout and of the readout with the short to chassis ground.

Unfortunately, we found that readout 4,4 was inoperative, representing a new failure. We show the layout of the array in Figure 2. Readout 4,4 is to one edge and next to the center line (see Figure 3). We have carried out a detailed analysis of this failure, attached as an appendix.

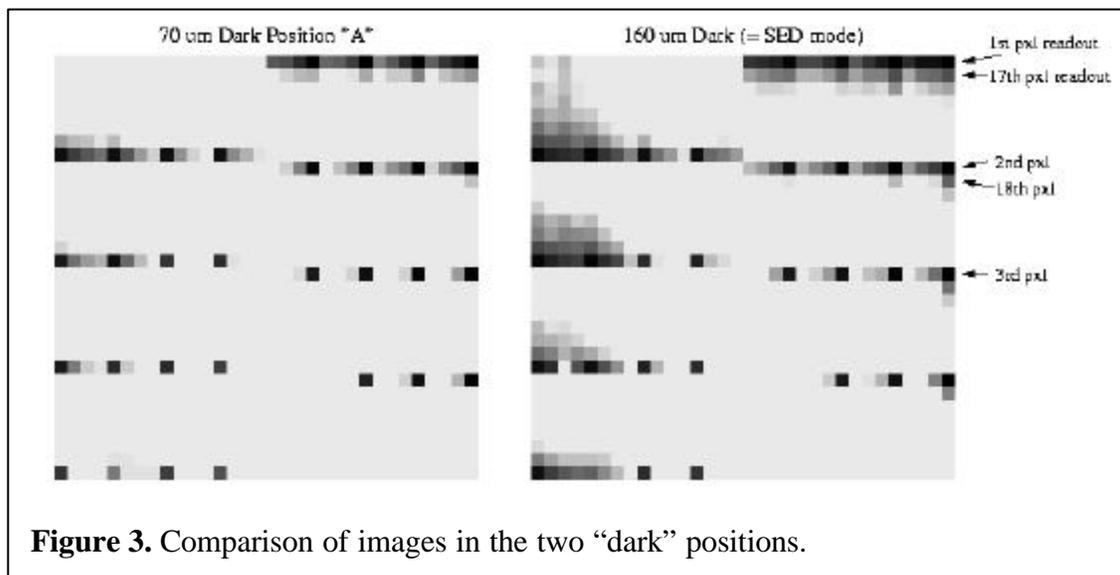
Figure 3. Comparison of images in the two “dark” positions.

More subtle indications of correct instrument operation from Figure 3 are that the slit is to the right, with the blanked off region occupying 7-8 pixels to the left (they are noticeably less saturated), and that in the region under the slit, there is stronger illumination toward the bottom. The bottom region is where the “blue” = 50 μ m light should fall, and given the high temperature of the telescope, should be brighter than the top “red” = 100 μ m zone.

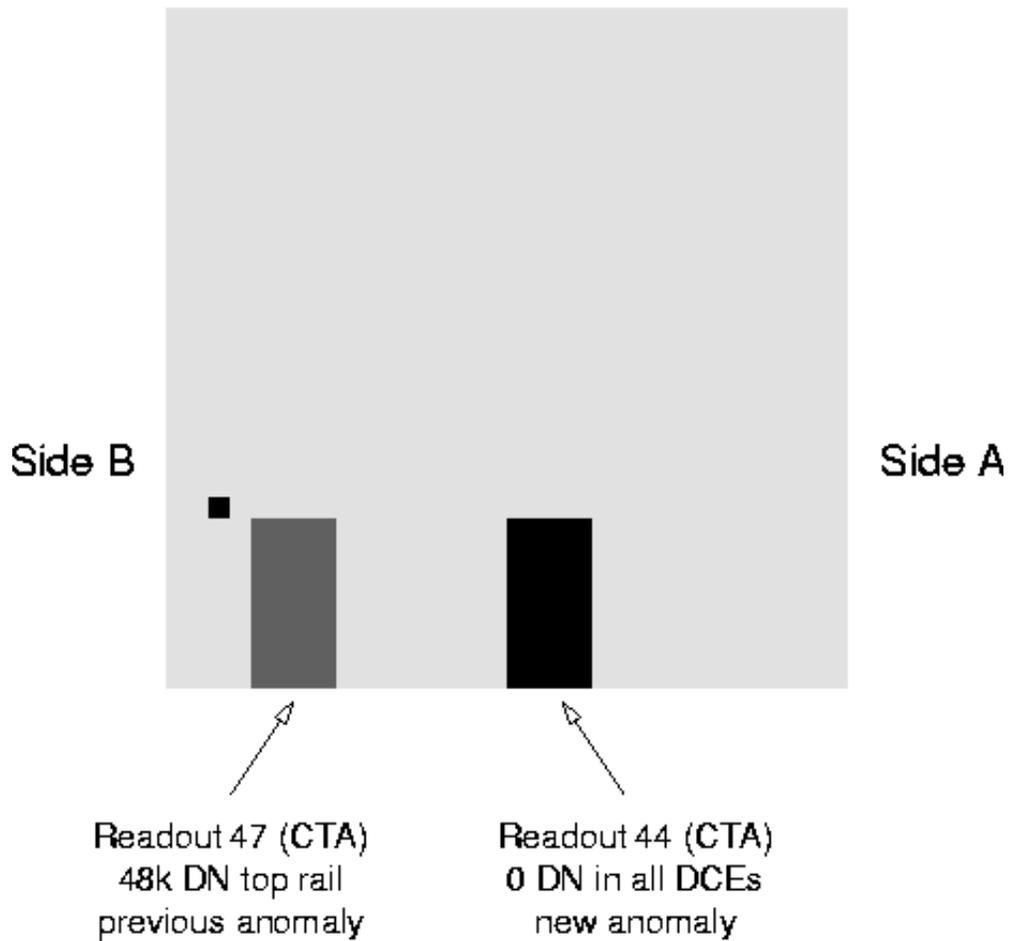
A greyscale representation of the output of the 70 μm array as it was throughout Campaign A1 is shown in Figure 1. Figure 2 shows the array output levels. Readout 4,4 is at zero for the duration of the test, and was not seen to deviate from this reading throughout Campaign A1. All the other readouts were saturated positive by the very high background level from the relatively warm telescope, except for readout 4,7. That readout was known prior to launch to have a short on its output to chassis ground through a resistance of approximately 40 k Ω . The resultant loading of the signal puts the saturation level below the nominal rail of the system. The data in Figure 2 indicate that the value of the short has not changed substantially between ground test and the on-orbit data.

Figure 1. 70mm Array Output. Readout coordinates start in the upper right corner. Readout 4,4 is driven hard to the negative rail. Readout 7,4 has a short to chassis ground similar to that observed previously. There is a bad pixel on readout 8,3.

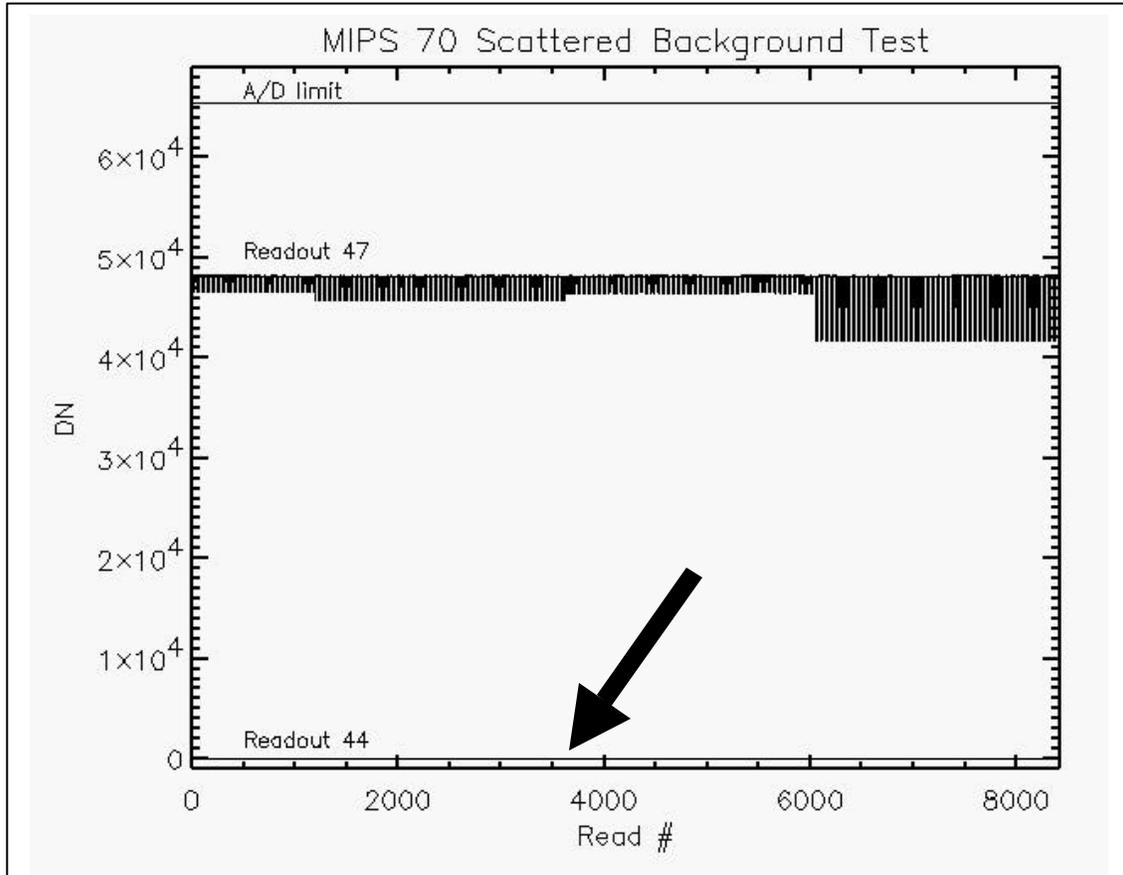
Figure 2. 70mm Array Outputs. 30 of the outputs were at the A/D limit, indicating full saturation. Readout 4,7 is also indicating saturation, but its output is dragged down by the partial short to CTA chassis ground. It also shows vestigial integration ramps that are off scale for the other readouts. Readout 4,4 (indicated by the arrow) is at zero and remained there throughout the test.

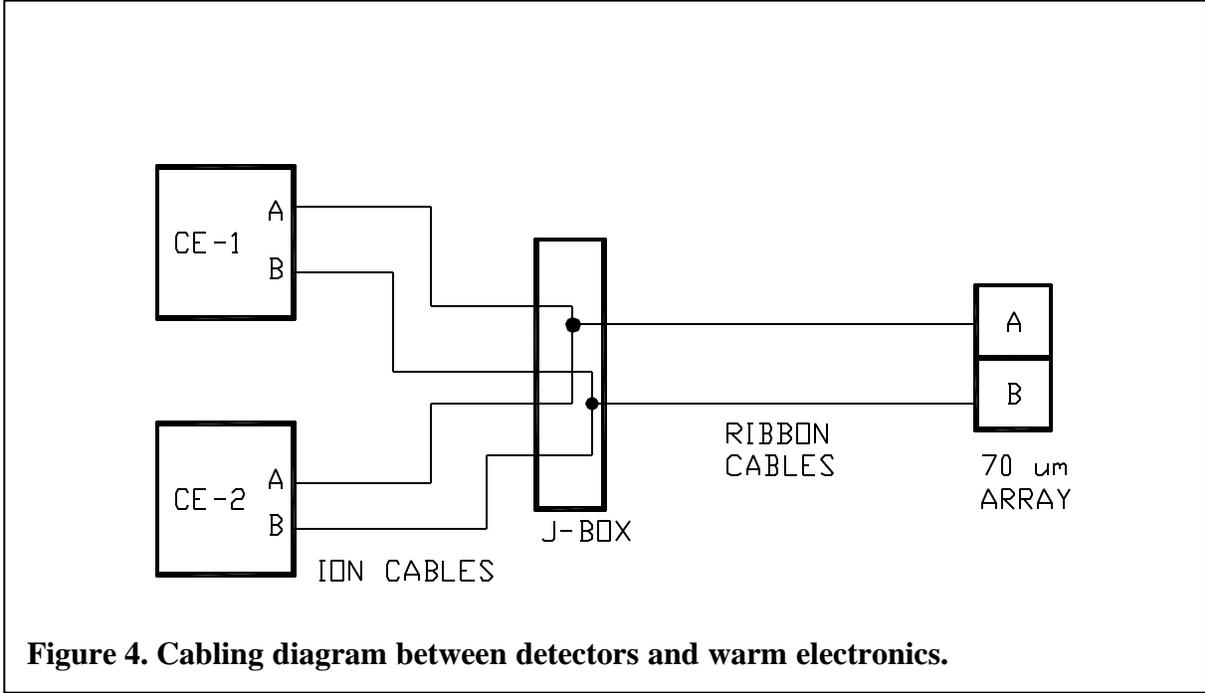
Figure 4. Cabling diagram between detectors and warm electronics.

External to the array, the failure could result from a break in the readout wire in the instrument cabling or connector, in the CTA ribbon cabling or connectors, in the spacecraft cabling from the junction box to the electronics, or in the junction box.

In the Combined Electronics box, for each of the 32 readouts of the 70 μ m FPA there is a 5 micro-amp current source in the warm electronics that is used to bias the source follower output amplifier in the FPA. This current source is also connected to the instrumentation amplifier in the combined electronics. If the connection between the current source and the output amplifier is broken, the current source would go to its positive rail voltage (about +7V). The instrumentation amplifier and the low-pass filter that follows have gains of -7 . Thus, if the connection were broken, the output of the low-pass filter would go to the negative rail. With the filter output at the negative rail, the ADC would produce all zeros. This is exactly what we are seeing.

A review of the positions of the wires involved indicates none of them are at the end of a connector, making it unlikely that the failure arises through a partially seated connector. Nonetheless, a workmanship issue in attaching to a connector pin or something similar remains a possibility. Issues of this latter type have already been discovered in the cryogenic ribbon cables, during ground testing.

The cryogenic cables have experienced significant changes in temperature between the two campaigns, due to the cooling of the telescope and various shields. Most of the thermometers associated with the telescope show a change of about 40K, from about 120K to about 80K. The behavior of the SIRTf cryogenic ribbon cables has been studied as described in Ball Aerospace SER S20447 – I&T (June 17, 2002). Of three flight spare cables, one showed a bad wire. The behavior was not reproducible from one cryogenic cycle to the next, but often problems appeared near temperatures of 100 to 150K. On some cycles, the conductor never failed completely down to < 100K. In tests of a second cable, known to have a bad attachment to a connector pin and removed from the flight hardware for that reason, intermittent behavior was observed during one thermal cycle but no hard failure occurred. From these tests, it does appear plausible that the behavior we have seen on readout 4,4 is associated with a bad conductor carrying its signal from the instrument to the junction box.

We therefore propose that the explanation for the anomaly on the readout 4,4 output is an intermittent failure on its output cable. Because we do not have data on the behavior of the cable at lower temperatures than achieved for Campaign B, it is not possible to project whether the problem is “fixed” as seen in that campaign, or whether the cable will open again later in the mission.

Given the uncertainty in the future state of this cable, we recommend that contingency planning continue on modification of the observing strategies with the instrument in case the readout output is lost.

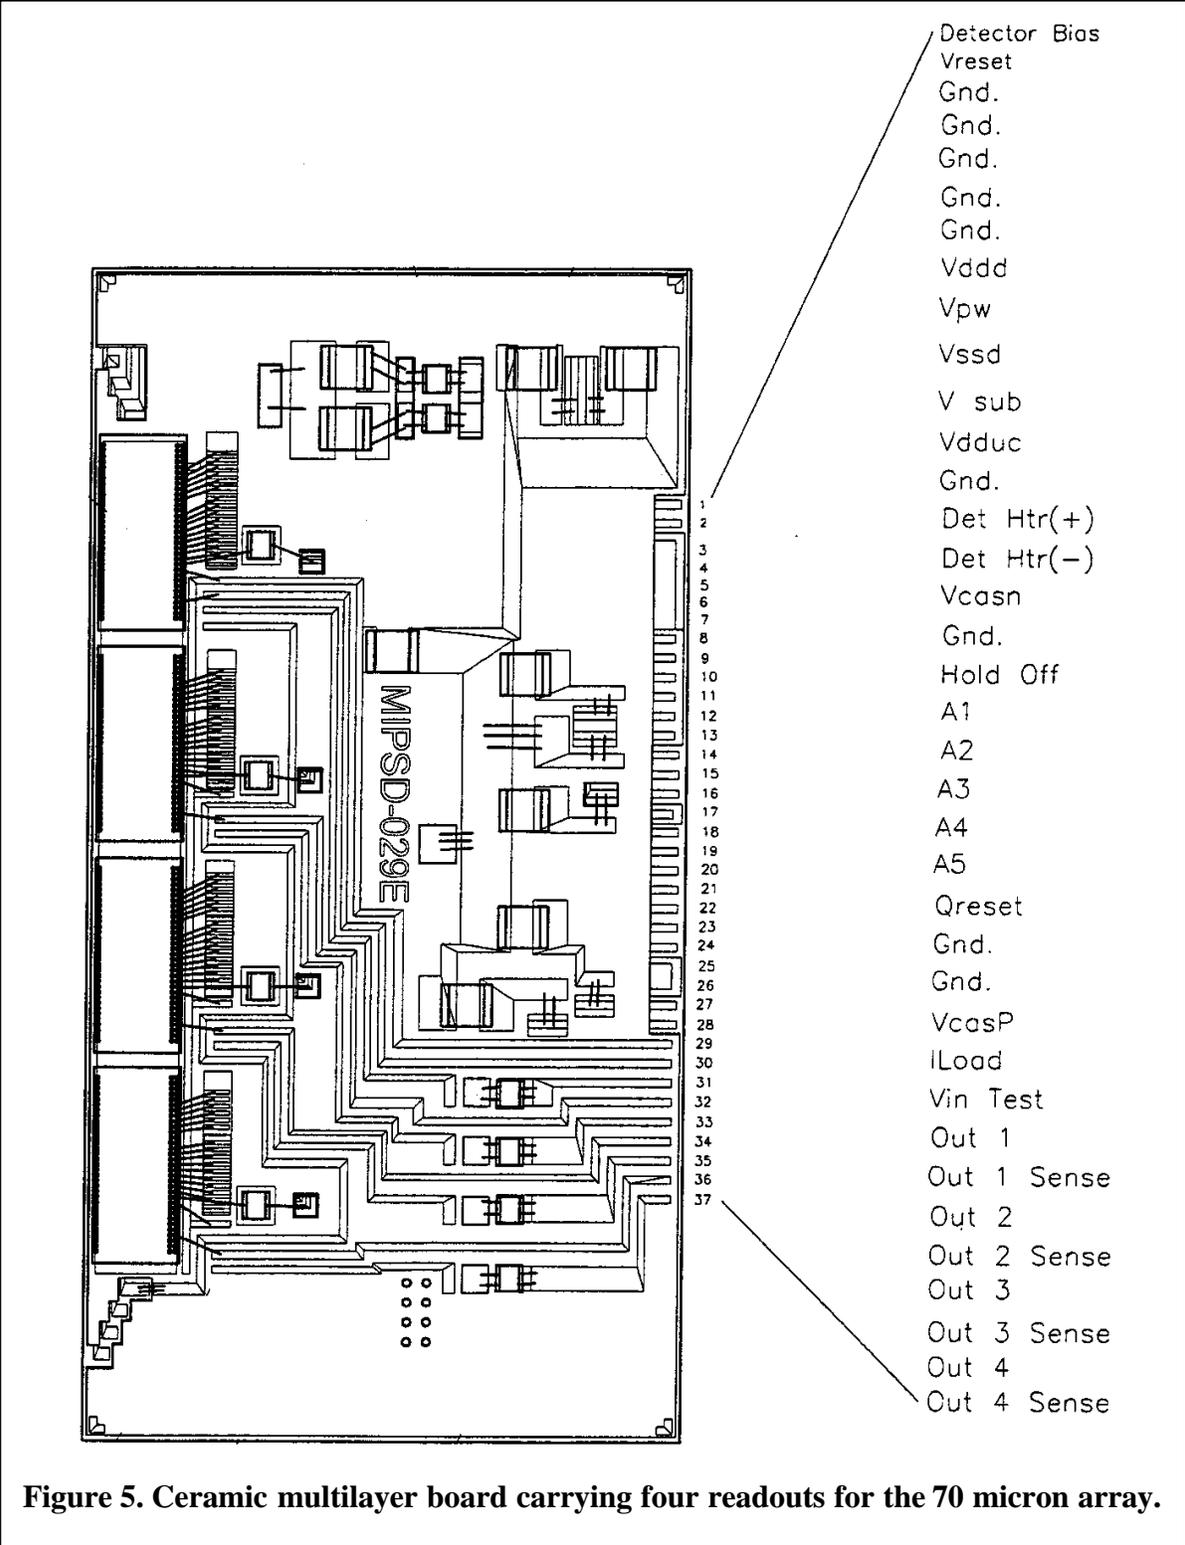
Figure 5. Ceramic multilayer board carrying four readouts for the 70 micron array.

The possibilities we have identified for a failure within the array are either that the readout itself has failed, or that a wire bond bringing a power line to the readout or carrying the signal to the output connector has broken (see Figure 5). A careful review of the telemetry indicates no asymmetry between sides A and B of the array in current draw, and no significant differences from ground readings except for those resulting from the very high background. In general, failure of the readout or of a power line would be reflected in a change in current draw. We conclude that a failure within the array other than in the output wirebonds is unlikely.

- As shown in Figure 5, the input signals to the readout are common to three other readouts, with the necessary circuitry embedded in the multilayer ceramic board carrying the readouts. Therefore, cable failures affecting input signals are not a credible cause for the anomaly.
- An output short to chassis would not drive the output to the negative rail – the observed fault would require a short to a positive supply, which seems contrived.
- An open sense line for readout (4,4) would not produce the result because the electronics includes a resistor on the sense line to ground to guard against this possibility.

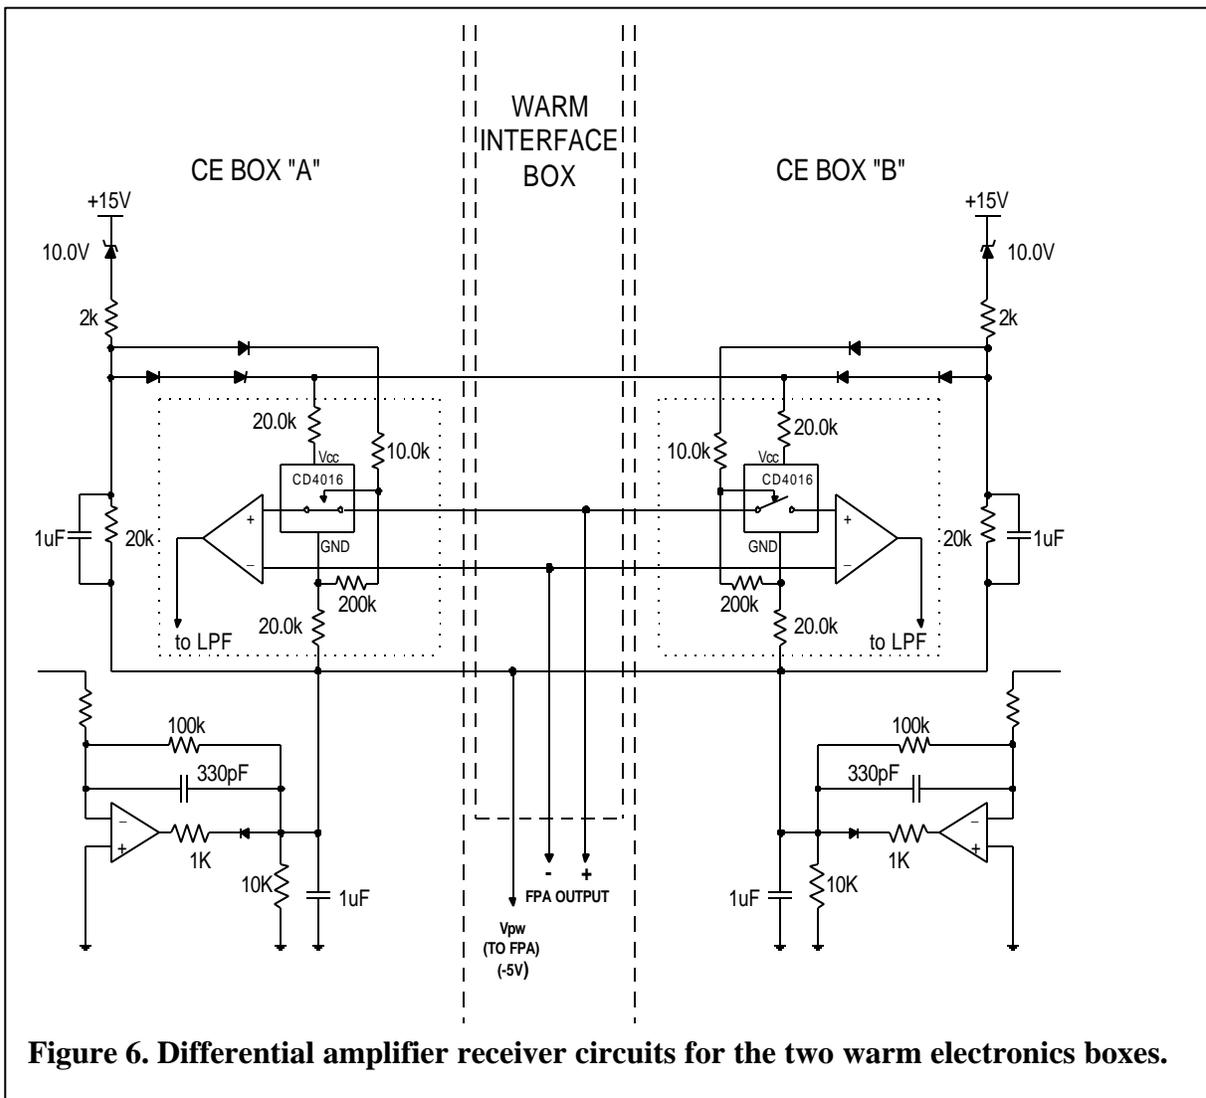
Figure 6. Differential amplifier receiver circuits for the two warm electronics boxes.

Figure 6 shows the receiver differential amplifiers in the warm electronics boxes. The decoupling relays allow the signals to be isolated to the box in use. Just as with an open signal cable, the differential amplifier would drive to the rail if the decoupling relay or electronics box connectors have failed open. In addition, there could be a failure in the differential amplifier itself. We could also end up at the rail with failures in any of the analog chain components downstream of it, up to the multiplexer. Finally, there are possible generic electronics failures such as in the motherboard in the electronics, in solder joints, etc.
