MIPS Campaign A1

September 10, 2003

MIPS 70 Micron Array Readout (Channel 2) Anomaly ISA Z81711

September 9, 2003

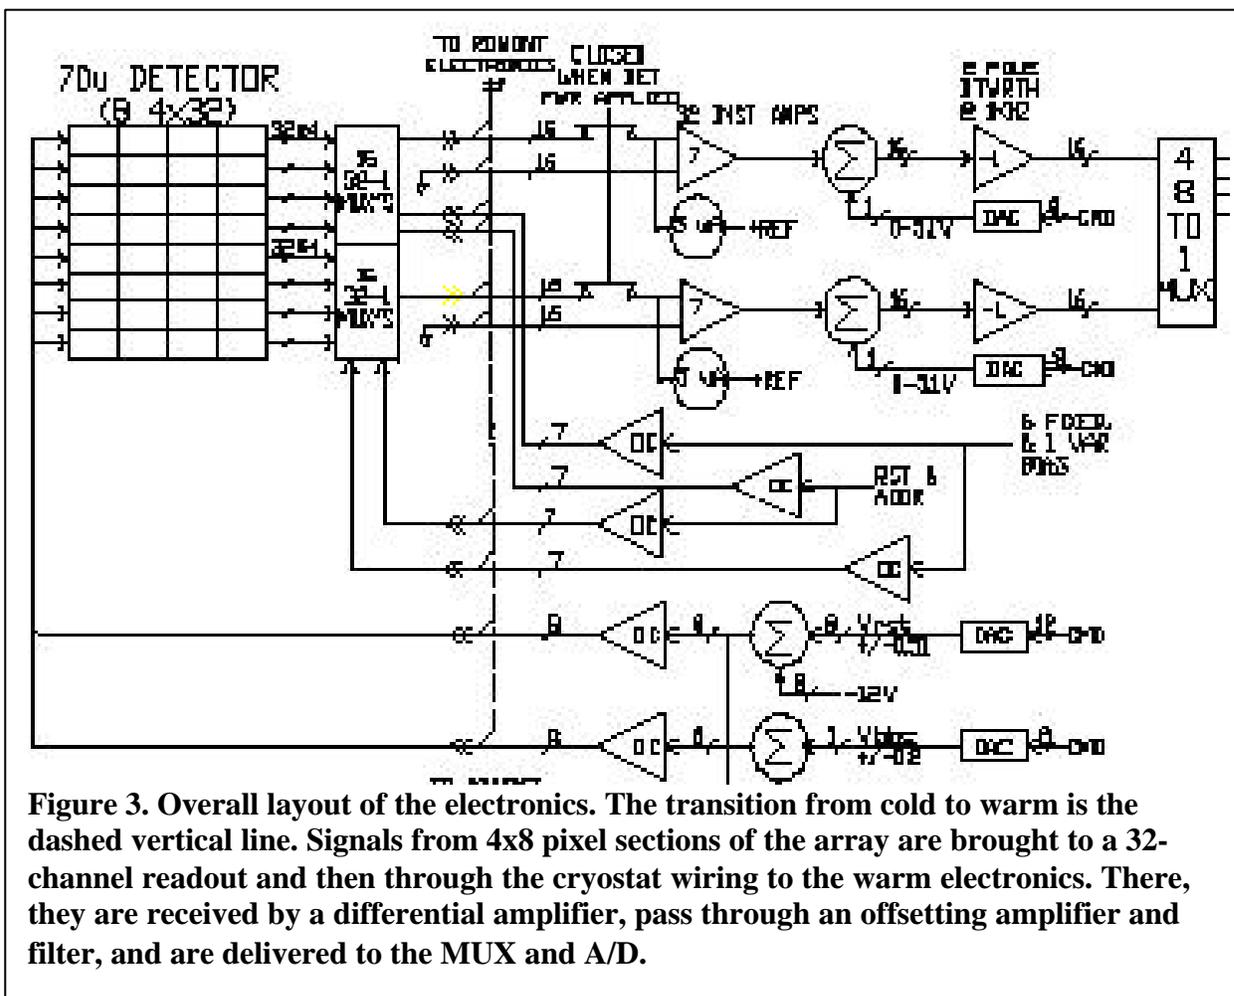
Figure 3 below shows the overall layout of the MIPS electronics. The cabling between array and warm electronics is shown in Figure 4 (reversed from right to left compared with Figure 1). Failures can arise in: 1.) the array; 2.) the cabling between warm electronics and array; or 3.) the warm electronics. The correct behavior of the remaining readouts in the array, and the restoration of correct behavior on readout 4,4 during Campaign B, both indicate that there is no problem on the digital side of the circuit, nor in the computer program that handles the data.

Figure 3. Overall layout of the electronics. The transition from cold to warm is the dashed vertical line. Signals from 4x8 pixel sections of the array are brought to a 32-channel readout and then through the cryostat wiring to the warm electronics. There, they are received by a differential amplifier, pass through an offsetting amplifier and filter, and are delivered to the MUX and A/D.
